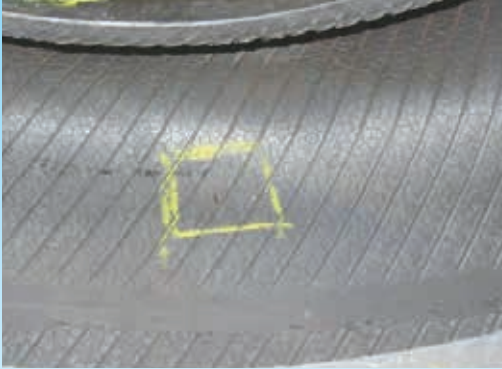
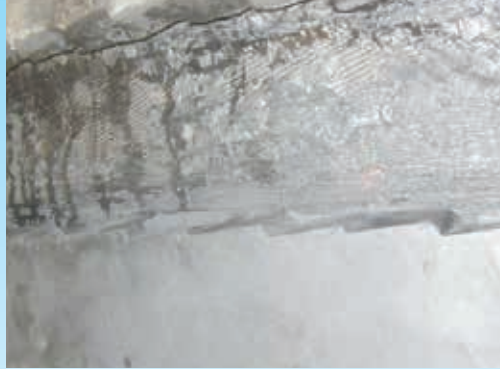
TREAD

Tread shoulder/rib is torn along the base of groove or from the shoulder due to pieces of metal such as nails, bolts and stones.

- Deteriorated adhesion by compressed air entering the casing structure, moisture, mud and sand penetrating through cuts due to obstacles.
- Developed rust in steel cords by moisture penetrating through cuts due to obstacles.
- Tyres easily tend to be cut under over inflation and/or overload.
- Running a tyre under-inflated due to a puncture, cut, leaking valve/stem/rim etc
- Sudden steering at a high speed and forced steering when the vehicle is not running.
- Heavy lateral forces against the foot print of the tyre.
- Sharp objects such as nails, sharp stones, glass and metal.
- Effects of overloading / under-inflation causes heat stress and fatigue in the shoulders which also results in failure of the casing components.

In order to distinguish cut separation from tread penetration separation, inspect the tread area near the separated portion. Normally moisture penetrates along steel cords of the belt.

- Check tyres and remove foreign materials in tread frequently, if cuts in tread are found out, repair them immediately.
- Use tyres under the recommended air pressure and load.
- Avoid rough/heavy steering at a high/low speeds and do not force steering when the vehicle is not running.
